Manhole Inspection Summary

Manhole # S23WW1016MH

Insp Date: **5/2/07 4:45 PM**

Location Address: **SPRINGHOUSE PATH**

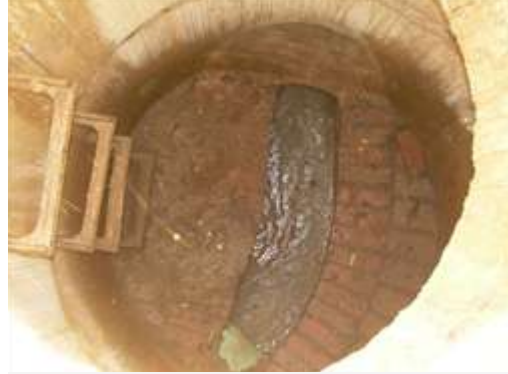
Top View

Evidence of surcharge - Bench debris.

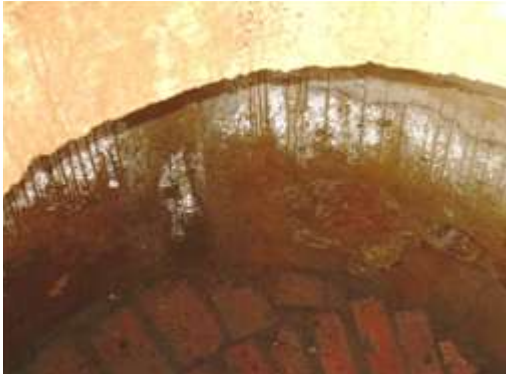
Defect

Frame Offset: **0** (in.) Condition: ☐ Sound ☐ Cracked ☒ **Leaks**

Infiltration: ☐ None ☒ **Joint** ☐ Cracks ☐ Mortar ☐ Roots ☒ **Wall**

Infiltration: ☐ None ☐ Joint ☐ Cracks ☐ Mortar ☐ Roots ☒ **Wall**

Frame leaks. Adjustment, Corbel and Barrel infiltration.

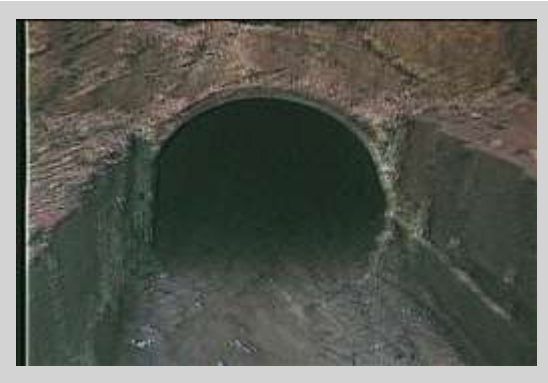
10 in. Circular Gravity Sewer Pipe Out @ 12 O'Clock

Channel deterioration.

Infiltration: **Evidence** Pipe Seal Cond: **Unknown**

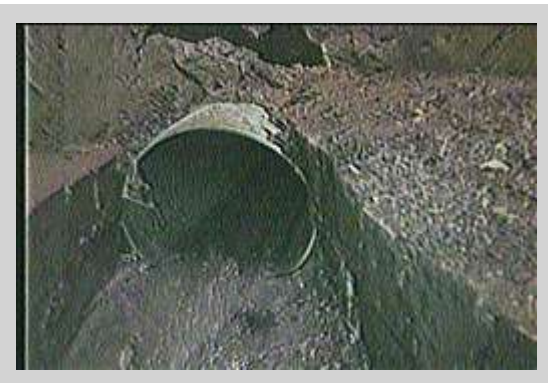
10 in. Circular Gravity Sewer Pipe In @ 7 O'Clock

Deposits: ☐ None ☒ **Mud** ☐ Sludge ☒ **Debris** ☐ Grease

Silt Depth: **0.5** (in.) Deposits Extent: **Light**

Infiltration: **Evidence** Pipe Seal Cond: **Unknown**
